Technical Memo

Occurrence of Nuisance Benthic Algae on the Southeastern Shores of Lake Huron, 2003

T. Howell
Water Monitoring Section
Environmental Monitoring and Reporting Branch
Ontario Ministry of the Environment

June, 2004

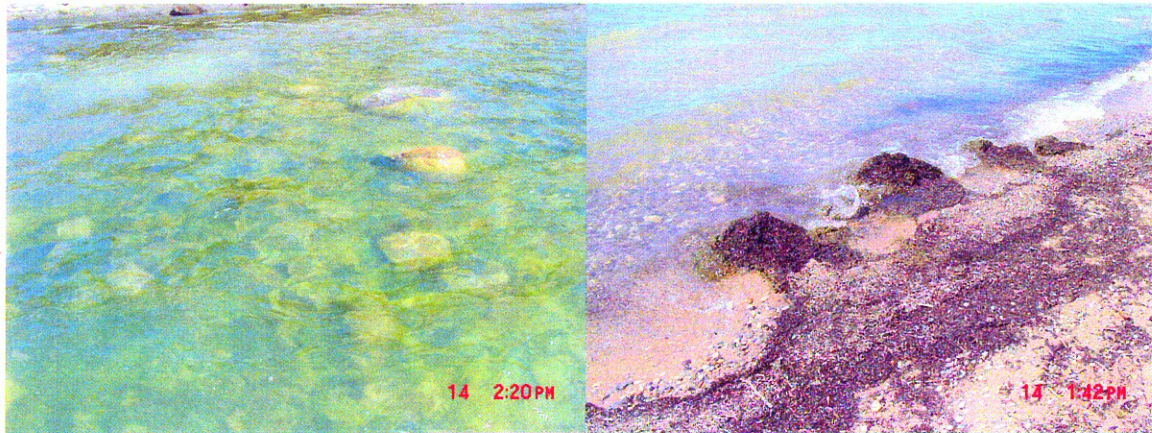
A small amount of algae was observed on shoreline north of the mouth of the Saugeen River (location 5, station 576). The location coincided with a localized area where *Cladophora* was growing on the lake bottom (Table 1; Figure 4) and suggests an area of nutrient input. The

enhanced growth of *Cladophora* is unlikely a result of the Saugeen River plume alone since the river plume affects water quality over a wide reach of shoreline. A small drain/creek draining to the shoreline near to where the algae was observed may have contributed nutrients to the area, however, water quality of drain/creek was not evaluated. Areas (locations 9 & 10) visited to the south of the Saugeen River mouth along the Southampton shoreline lacked any accumulation of algae on the shoreline.

Figure 4. Location 5 (Station 576) just north of the mouth of the Saugeen River with algae accumulated on shore. The area of algal fouling coincided with a localized area of *Cladophora* growth in the shallows along the shoreline.

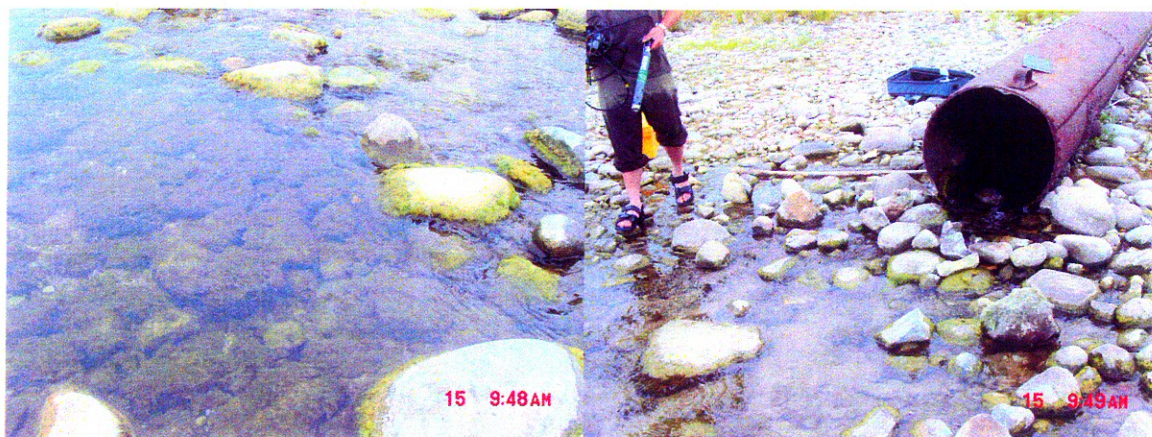
Areas of shoreline examined at Port Elgin were largely free of algae. A small area with *Cladophora* was observed on rocks just north of the harbor (location 15), but was limited to shallow water adjacent to shore and a ditch that was possibly a storm sewer (Figure 5). A slight amount of dead algae was present on the shoreline. Slightly north of this location at station 578 (location 14), the lake bottom was free of any visible algal growth (Table 1), as was the case for most of the shoreline. Similarly, the lake bottom was also relatively free of *Cladophora* at Macgregor Point (location 11, station 577) south of Port Elgin (Figure 6; Table 1).

Figure 5. Location 15, north of the Port Elgin harbor, where *Cladophora* was limited to very shallow water immediately adjacent to shore and near a drain, which was possibly a storm sewer.

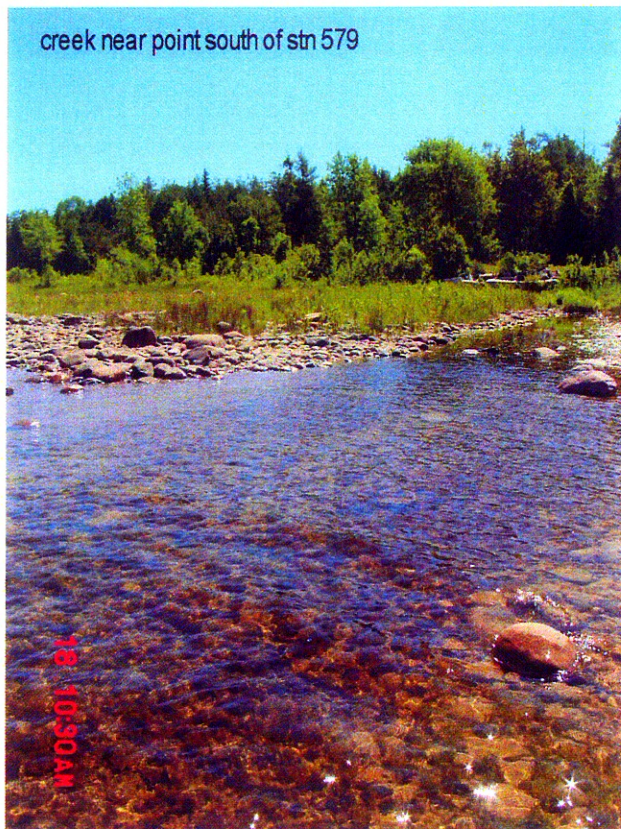
Several shoreline locations were visited on Sunset Drive in the vicinity of the Brucedale Conservation Area. At location 79, where Concession Road 12 meets the lake, there was no indication of *Cladophora* growing on rocks in shallow water or washing up on the shoreline. Roughly 500m north along the shore, patches of *Cladophora* 2 – 10 cm thick were seen growing on rocks near the waterline. At this location, algae was also observed on the dry bed of a creek/ditch. South of the conservation area at station 579 (location 16), rocks were largely free of *Cladophora* (Table 1). However, a small area of lake bottom, slightly south along the shore (location 60) and adjacent to a small creek/ditch, was found to have a lawn of *Cladophora*

(Figure 7). The area with *Cladophora* extended < 50 m along shore from the mouth of the creek. A small amount of algae was accumulated on the shoreline adjacent to the mouth of this small creek/ditch.

Figure 7. Location 60 having algal growth adjacent to a small creek.

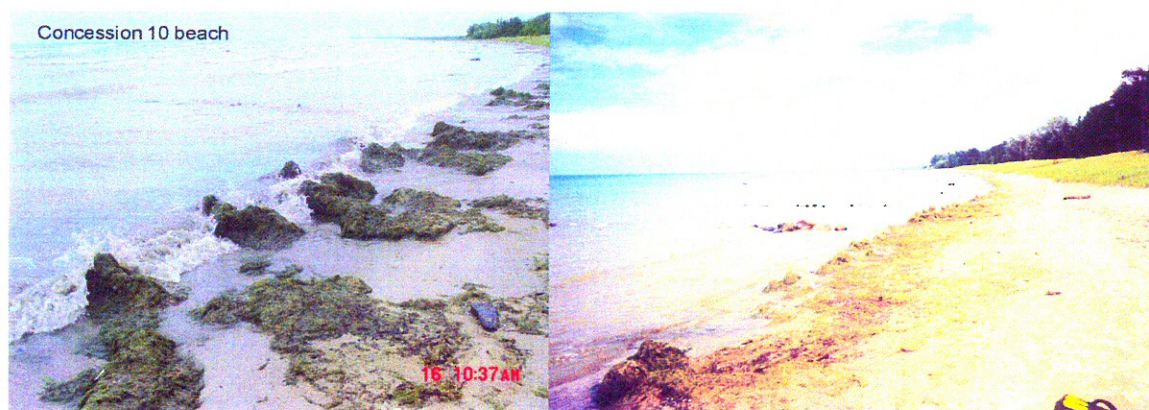
There was an extensive area with algae on shore at Poplar Beach, where Concession Road 10 intersects the lake (Figure 9). Intermittent windrows and clumps of algae were widely distributed along the beach, but not in great quantity. Residents had raked the algae into piles on the beach in some locations. Observation of the lake bottom (location 52, station 581) revealed that growth of benthic algae was strongly related to depth. *Cladophora* was abundant on the rocks from the shoreline to depths of 0.5-0.7m but absent on rocks at depths greater than 1m. A band of algae appeared to extend along the shoreline. Additional in-lake observations (to a depth of ~1.5m) were made at a site (location 55) north of location 52 where a small creek/drain meets the lake. Two spatial patterns in algae were observed. A length of shoreline roughly 5 - 20 m coincident with the drain/creek was covered with dark green/black filaments of *Cladophora* to a depths of ~1.5 m. Beyond this area growth of *Cladophora* was distributed along the shoreline as small clumps on rocks and was limited to depths of ~ <0.5 m.

Figure 9. Location 36 Concession Road 10 with intermittent windrows, clumps, and patches of algal material distributed along shoreline.

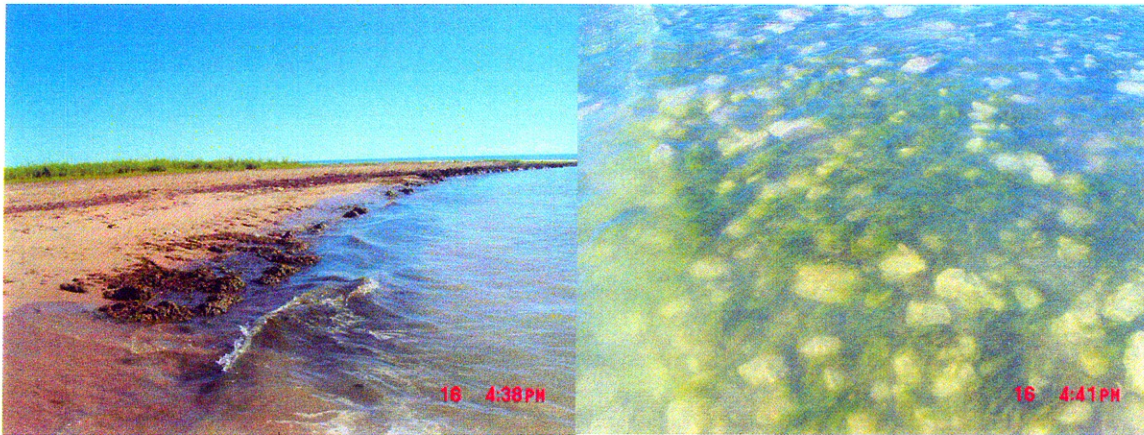
At Point Farm Provincial Park algal material was accumulating along a beach on the north side of a rocky point into the lake (Figure 12). On the north side of the point, an abundance of *Cladophora* was observed to depths of ~0.4 m (location 50, station 580). Areal cover was 50 - 100% and the *Cladophora* layer was ~ 5 cm thick (Figure 12; Table 1). In contrast, *Cladophora* appeared to be mostly absent on the south side of the point. A large number of gulls were observed roosting on the point.

Figure 12. Location 50 (Station 580) Point Farms Provincial Park where *Cladophora* was abundant in the shallows on the north side of the point, but absent on the south side. A large number of gulls were observed roosting on the point.

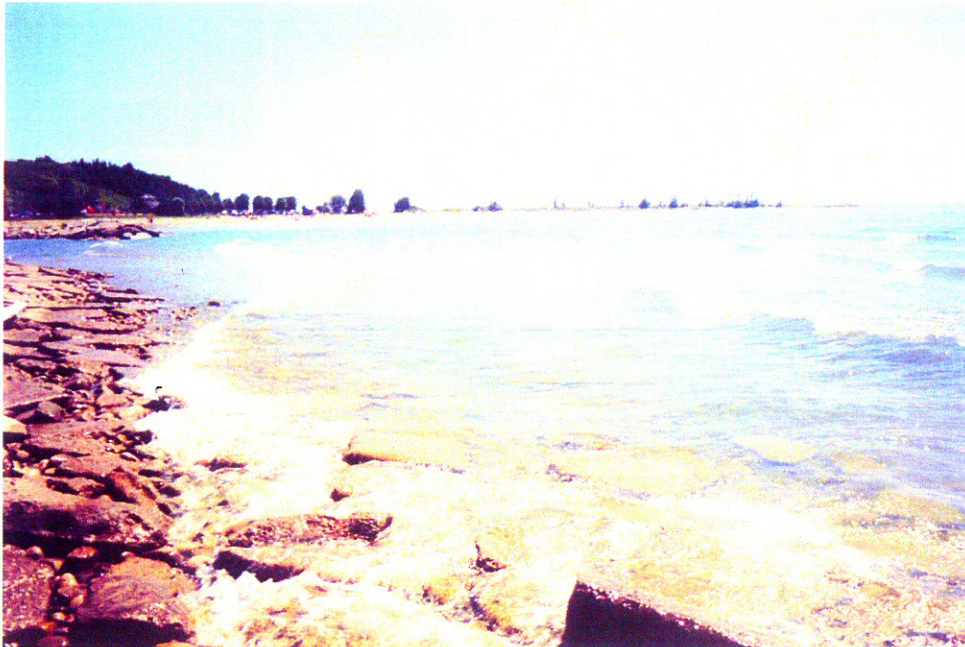
Algal fouling of shoreline was observed near the discharge of the Goderich sewage treatment plant otherwise there was little algae on the shoreline at Goderich. Rotting algae was pooled at the waterline (Figure 14) near the discharge. A large man-made spit separates a beach area from the point where the sewage treatment plant discharges into the lake. *Cladophora* was abundant on rock surfaces of the spit near the sewage treatment plant but appeared to be absent on rocks on the beach side of the spit. Fouling of the Goderich shoreline by algae has been reported previously (Jackson 1985). At station 590 (location 73) south of the harbour, the lake bottom was visibly free of *Cladophora* growth and no algae was seen on the shore (Figure 13). The shoreline to the north of the mouth of the Maitland River is not publicly accessible and was not surveyed.

Figure 13. Location 73 near Goderich (Station 590) where a spit of land (background) separates the sewage treatment plant discharge from the beach area (foreground).

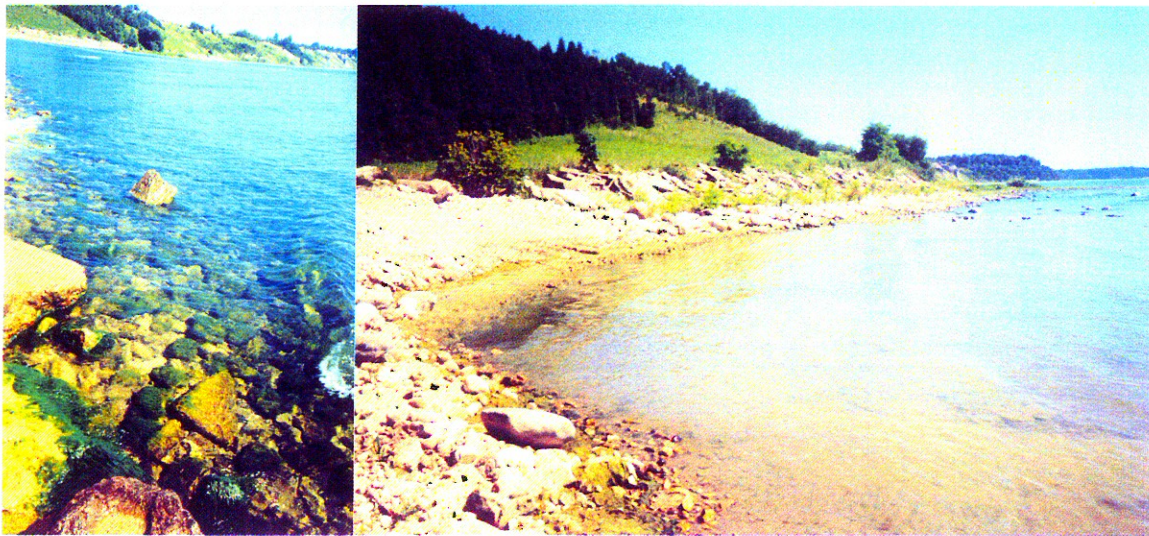
Figure 14. Location 74 near the Goderich sewage treatment plant discharge into Lake Huron, showing an area of lake bottom with algae.

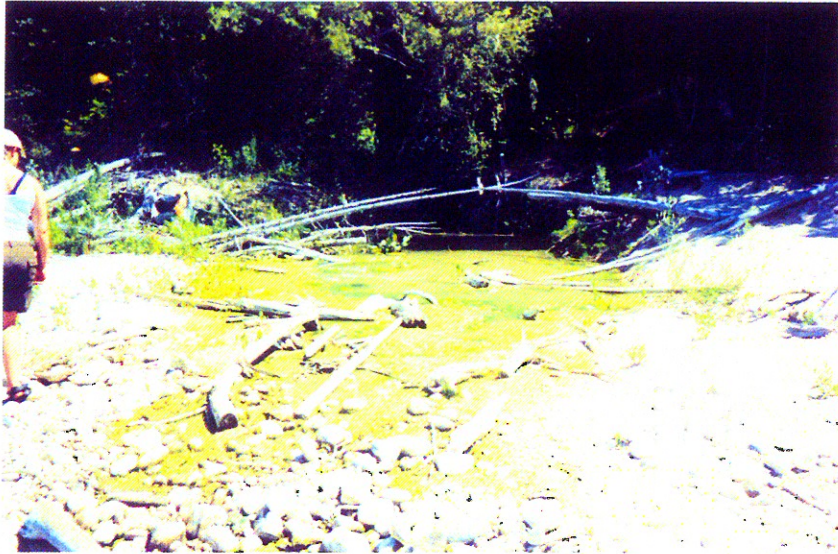
Figure 15. Location 70 with a drain covered with algae near the shoreline.

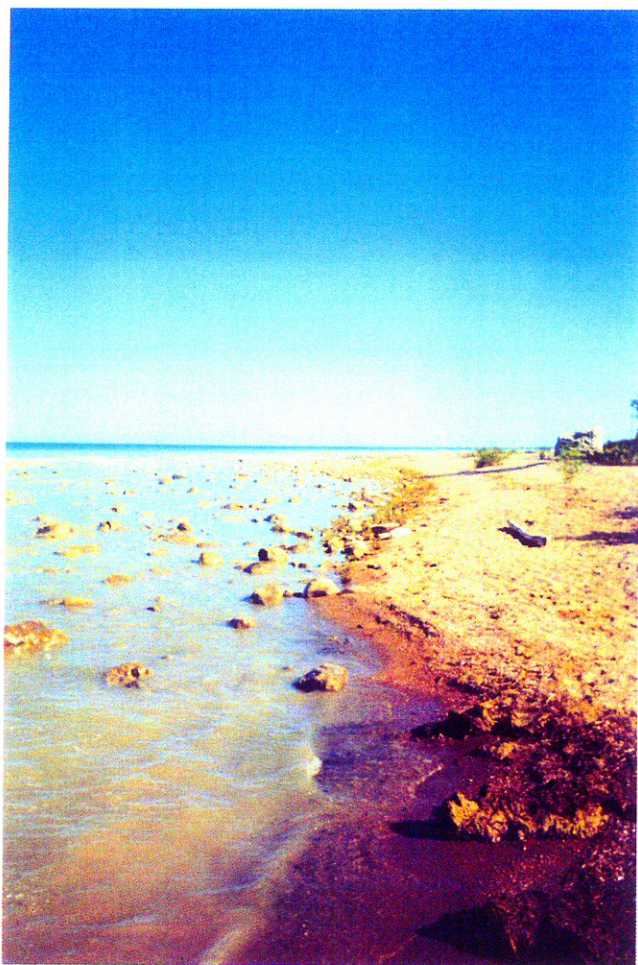
A small amount of *Cladophora* and detritus was observed at the waterline and washed on shore at a site on the southern end of Bayfield Beach (Location 66) (Figure 16). *Cladophora* was not visible on the rocks in the immediate area. Slightly north, at station 586 (location 64) and location 65, the shoreline was also free of algae. However, at Location 65, *Cladophora* that was observed in the lake on rocks at water depths of 20 - 30 cm. High turbidity precluded visual observation of the lake bottom.

Figure 16. Location 66 south of Bayfield where a small amount of *Cladophora* and detritus was observed at the waterline and washed on shore.
