# Nearshore Water Quality

A Preliminary Report on  
Historical Nearshore  
Water Quality  
Information for  
Southeastern Lake Huron

Sauble Beach to Sarnia

The Lake Huron Centre for Coastal Conservation

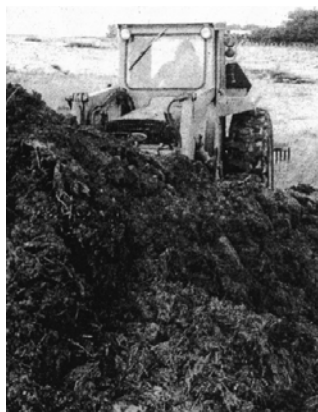
Figure 4—Loader removing algae from the beach at Goderich (July 2001)

The algae was particularly problematic for the Town because of the foul odour it produced. Lab analysis of the algae was undertaken in 2001 and 2002 (late June each year) and found it to contain *Rhizoclonium* spp., a filamentous algae of the Cladophoraceae family (GAP, 2002).

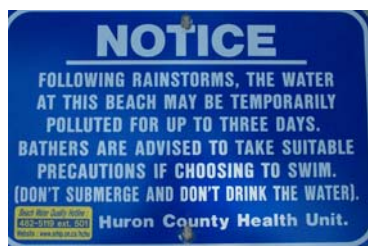
Figure 5—“Red” and “Blue” public notice signs used by Huron County Health Unit

indicating hazardous bathing conditions (see Figure 4). The Grey Bruce Health Unit has recently adopted a similar two-sign system. The Huron County Health Unit posts its weekly beach testing results on its website and also operates a water quality telephone hotline. From a public education and health protection standpoint, it would appear that the Huron County Health Unit has the most effective surveillance and public reporting system.

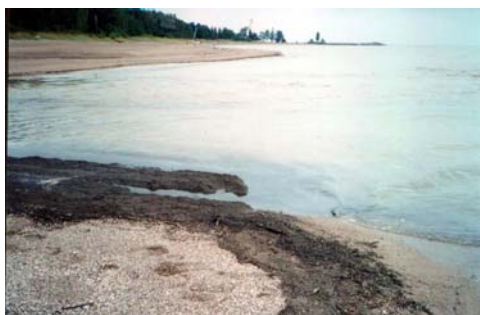
Figure 6—Black, sewage-smelling material washed up on beach at Point Clark (rotting algae) August 2000.

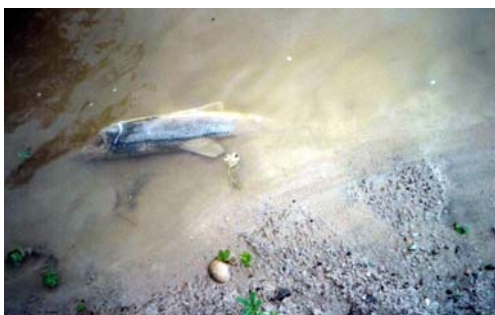
Figure 7—Dead fish in area creek at Point Clark, where rotting algae was floating into the lake August 2000.
